**Ilya Antipov and Alexey Gervais**

**THE BRICKS FROM ST NICHOLAS CHURCH  
AT LIPNO NEAR NOVGOROD (1292) AND  
THE ORIGINS OF THE NEW NOVGORODIAN  
BUILDING TRADITION**

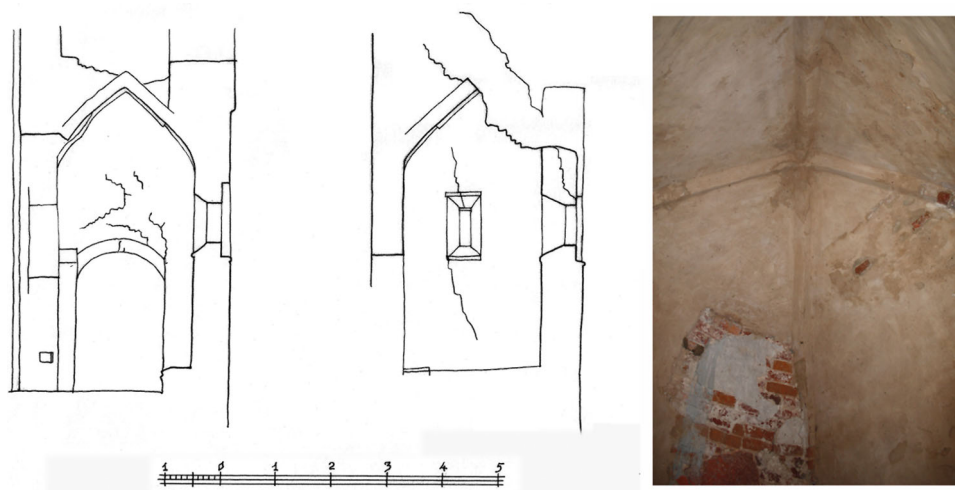
**Fig. 3.** St Nicholas church at Lipno near Novgorod (1292). Covered vaults in the corner chambers of the catechumena. Draft by Petr Maksimov (Maksimov 1952, 97). Photo by Ilya Antipov.

The question of the origins of the new building materials, which were used for the first time in the late 13th century (in the church of St Nicholas at Lipno) is very important in the context of the entire history of Novgorod architecture. In St Nicholas church the traditional Old Russian cross-in-square plan and the trefoil type of roof, which was widespread in the architecture of Old Russia in the late 12th – first third of the 13th centuries, some decorative and constructional features, which were common for the architecture of the pre-Mongolian epoch were combined with the architectural details which originated from the monuments of European architecture. Small arcades on the upper parts of the façades and on the drum, coved vaults in the corner chambers of the catechumena, cross-shape windows and niches, stone crosses on the façades are among these new features (Figs 2–5).

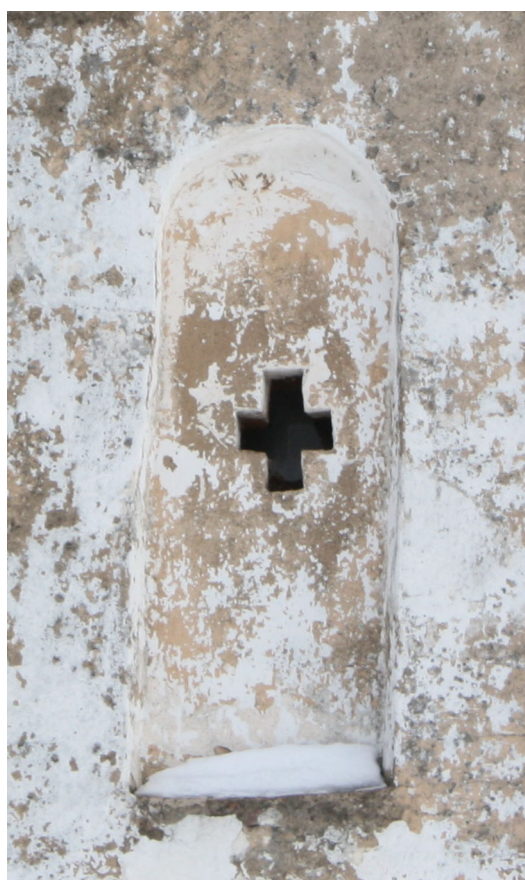
**Fig. 4.** St Nicholas church at Lipno near Novgorod (1292). Cross-shape window on the western façade. Photo by Ilya Antipov.

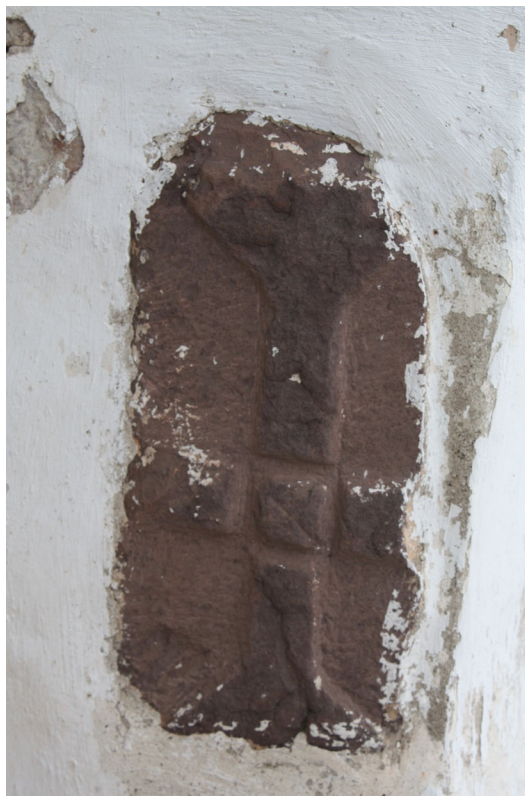
**Fig. 5.** St Nicholas church at Lipno near Novgorod (1292). Stone cross on the western façade. Photo by Ilya Antipov.

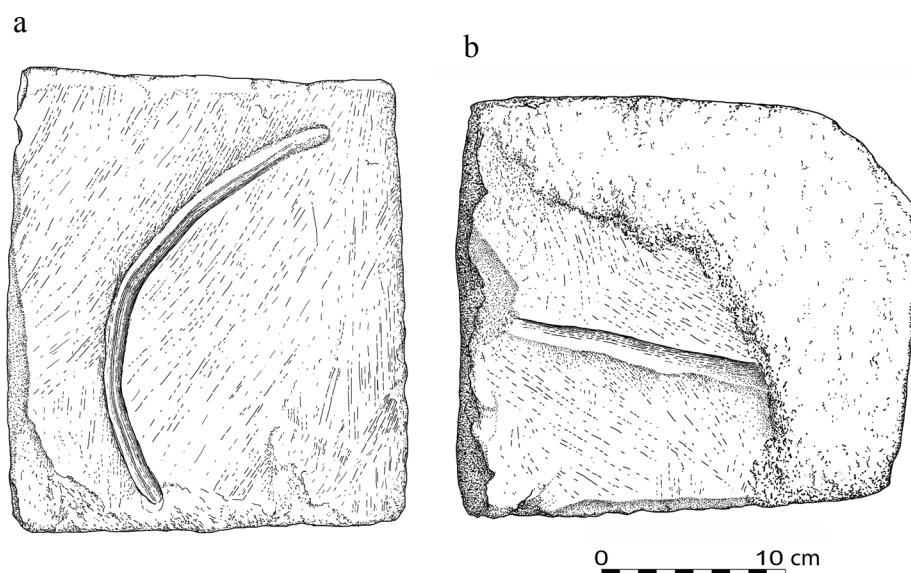
**Fig. 7.** St Nicholas church at Lipno near Novgorod (1292). Simple markings on bricks (a, b). Draft by Ksenia Dubrovina.

Some bricks of the Lipno church have markings, as it was already mentioned. There are simple marks (bow-shaped or straight line) among them (Fig. 7). We also know three versions of more complicated markings (Fig. 8): padlock-shaped, flower-shaped and horseshoe-shaped (probably, L. Shulyak wrote about the latter mark, when she mentioned the signs in the shape of “C” letter, made by the finger on raw bricks – Gladenko et al. 1964, 218). It is possible that these signs marked a new batch of bricks or they were the special signs of the masters. Unfortunately, it is unknown how many bricks with markings were found (only five bricks, all with different markings remain).

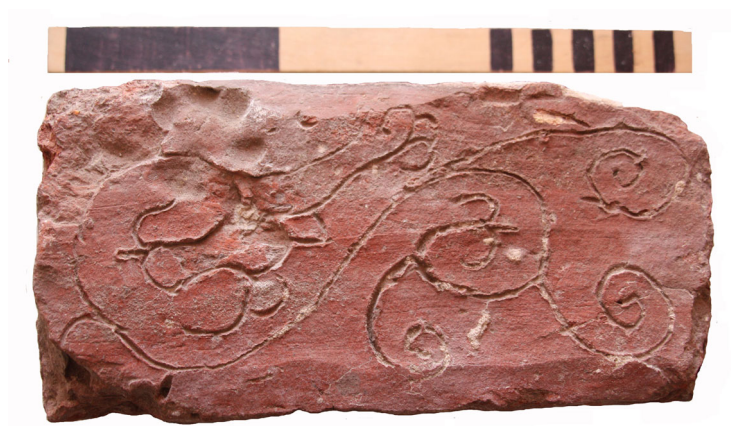
**Fig. 9.** St Nicholas church at Lipno near Novgorod (1292). The brick with an ornamental drawing. Photo by Ilya Antipov.

L. Shulyak mentioned that some bricks with vegetative ornament were found (one of them is stored in the collection of the Novgorod museum – KP-42860-04/SD-967-24). The ornament was made by pointed chip on a raw brick, and then the dog trod on the brick, which had not been burned yet (Figs 9–10).

L. Shulyak wrote that one of the ornaments had a slim distinct contour with the parts, shaded with right lines, which looked like engraving (Gladenko et al. 1964, 218).
